# ECC ROADS COMPLAINT

Reference : ECC-ROADS-16-002

Location : Chalks road, Witham

Issue : Chronic surface break-up leading to potholes.

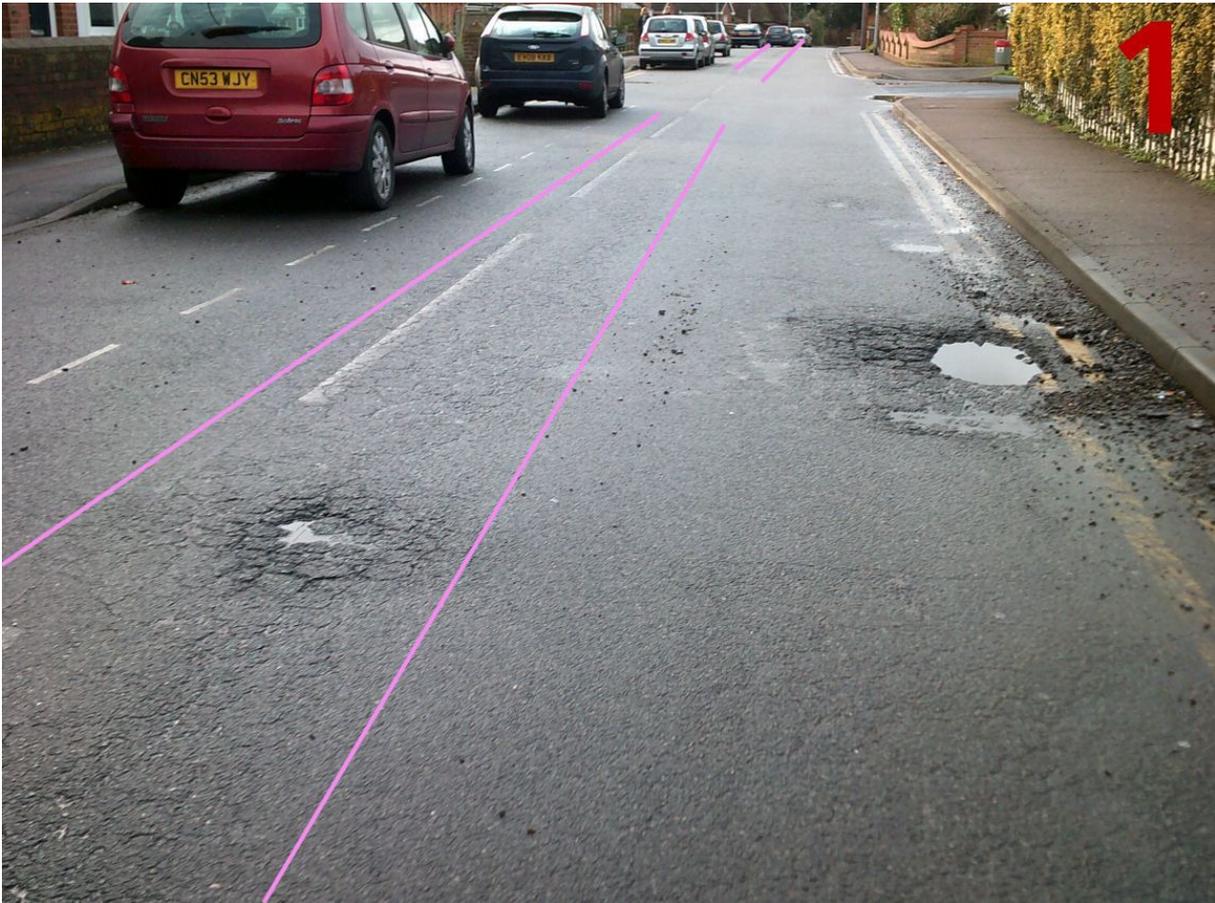
Photo 1 faces West. It shows a rapidly expanding pothole and large sections of crazing between the pink lines. Photo 2 from the same position faces east showing incipient potholes. Photo 3 shows detail of the pothole. From the surrounding debris and state of the adjacent surface it is clear that this is growing quickly.

Discussion: The crazing on the surface has been visible for two to three years. Obviously it wasn't going to get better. Photo 1 gives an idea of the extent, which is practically the whole length. The centre crazing and side crazing shown are typical. There have not been any actual potholes until this winter. Photos 2 and 3 show the inevitable progress from wet-patch to hole. Note that we haven't had any frost or snow yet. The quantity of ejecta shown in photo 3 tells how quickly the hole is being formed.

- .1 Rapid response patching. Furthermore, given the way the area around the actual hole is broken (see photo 3) a splot of tar in the hole is not going to work, so a method that doesn't require second and third visits needs to be used.
- .2 Short term crack sealing (or other preventive measure) to reduce or eliminate the waterlogged situation seen in photo 2.
- .3 Long term remediation.
