A tour of Witham

Witham Cycle Campaign reviews the Witham Cycle Network - Part 3

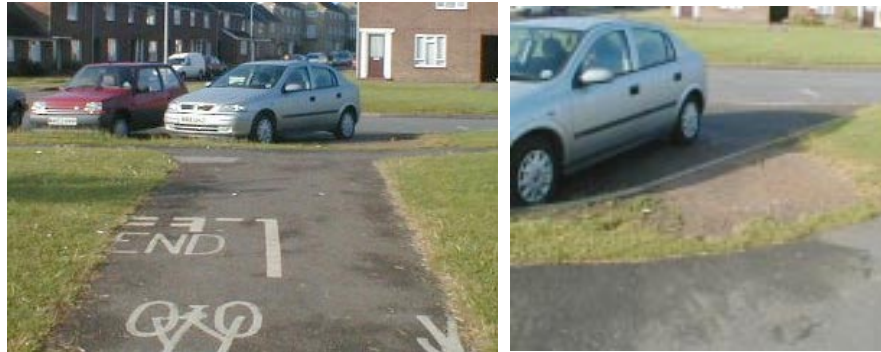
Cycle paths stop short of road and don't have dropped kerbs.

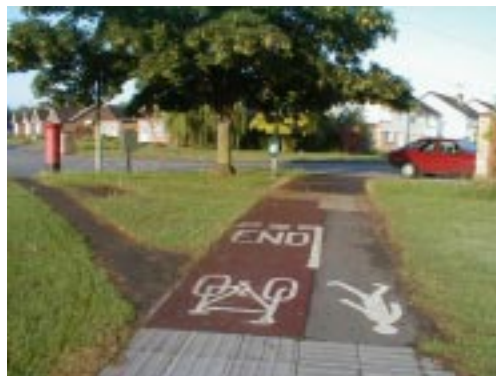
Laurence Avenue. Path ends in a parking bay!

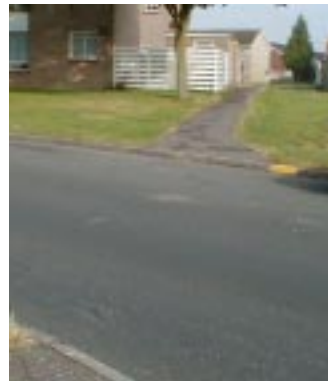
← Armond Road - stops short

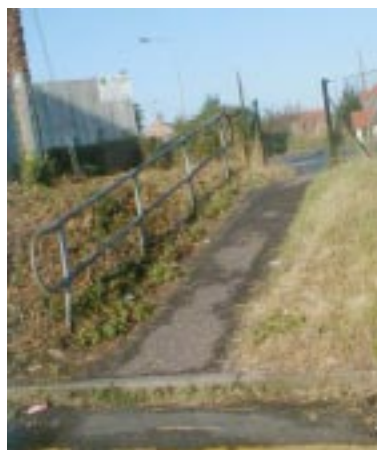
Allectus Way - drop kerb on one → side of road only.

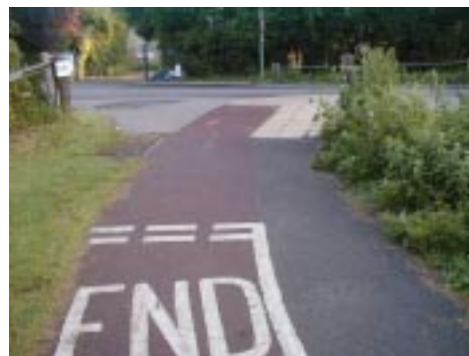
← Kerb at White Horse Lane (N) on approach to Bellfields. ↓ Chipping Hill

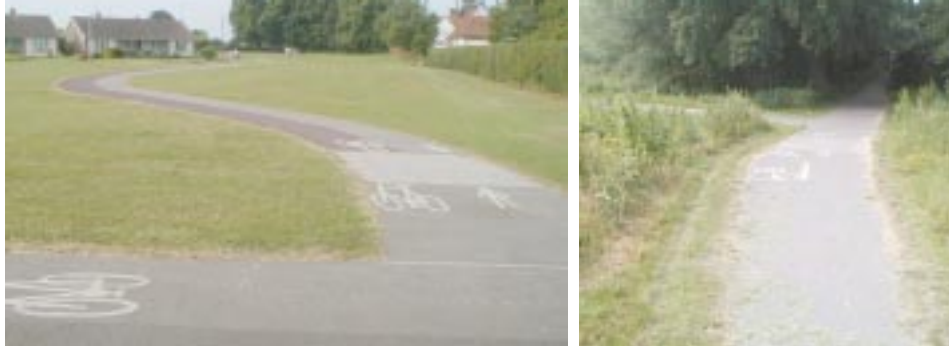
Artistic curves serve no purpose in this view towards Pattison Close. Where paths meet no allowance has been made for the turning circle of a bicycle. The second photo shows the north side of the bridge further down the Riverwalk. This junction is almost impossible to negotiate when coming off the bridge. This view taken before the nettles grow to add extra spice to the manouever.

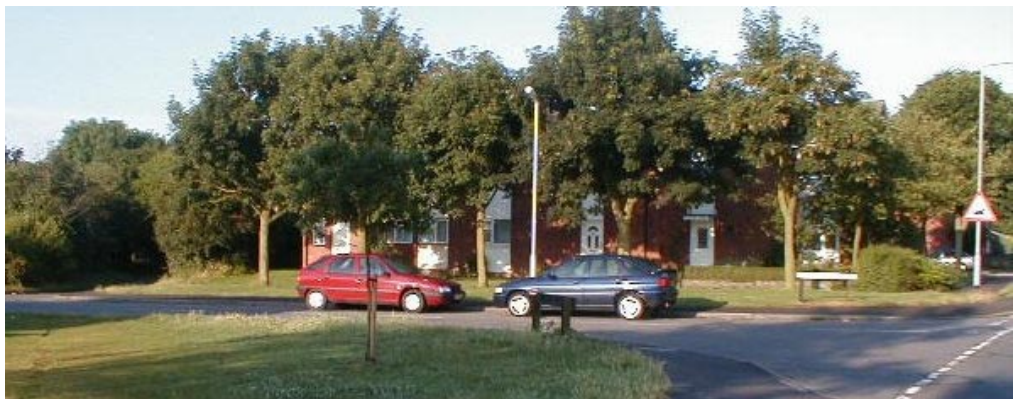
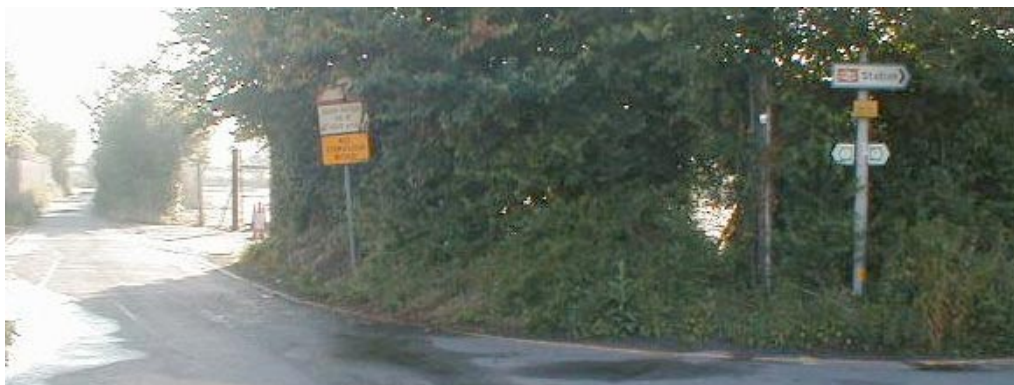
There are no encouragements to use legal routes. Simple signs let people know routes are there and legal. These shots show the two ends of the Cuththroat lane route. In the first you'd be hard put to see there are two useful routes vanishing down the hole between the trees on the left. In

the second signs indicate a footpath but no hint for cyclists.

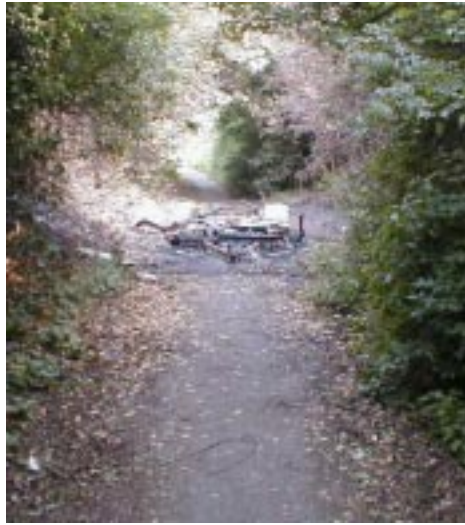
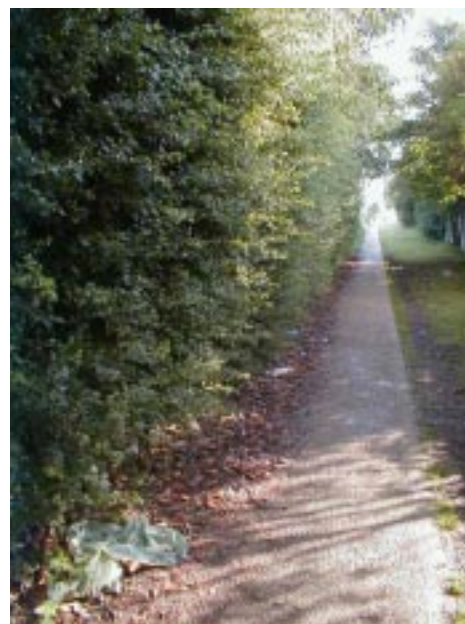
When Motts Lane was completely blocked by a dumped caravan neither the County Council or The District Council for four weeks. If this had been a road used by cars the obstruction would have been removed in hours.

Predictably more rubbish was dumped and eventually set alight.

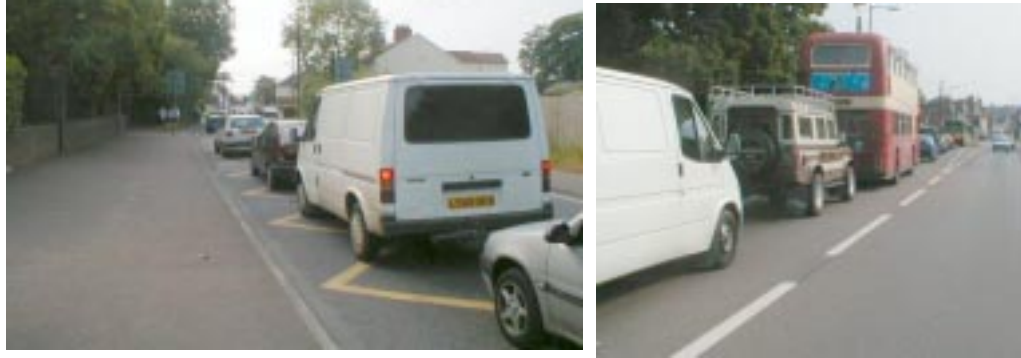
Bridge Street traffic lights

It is generally recognised that queue-busting is one of the major advantages that cycles have over cars and is therefore to be encouraged. However this can be very hazardous unless a well identified and clearly separated cycle lane is provided.

When a cyclist encounters a queue they can try creeping by on the inside or the outside. On the one hand there is the possibility of being squeezed against the kerb (often fatal) or dealing with oncoming traffic in the middle of the road. Where Collingwood Road approaches the lights at the George is a particularly bad example of an inside trap like this.

If at all possible these very busy lights need cycle approach lanes and advance stop lines.

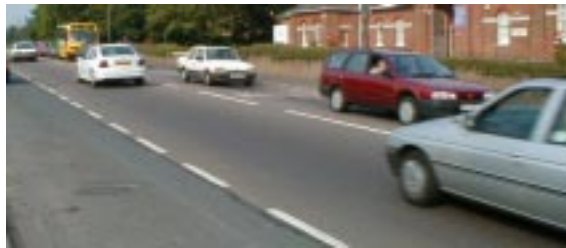
The problem becomes **much worse** if the queue starts to move. The picture on the left shows the bus yet to accelerate as the red and white cars have done. As they do so they overtake cyclists

who they may not have seen coming up from behind. The cyclist may find themselves being squeezed, undertaken, tailgated. If that wasn't enough the cyclist has to get into the right position across the road to take whichever exit from the junction they want.

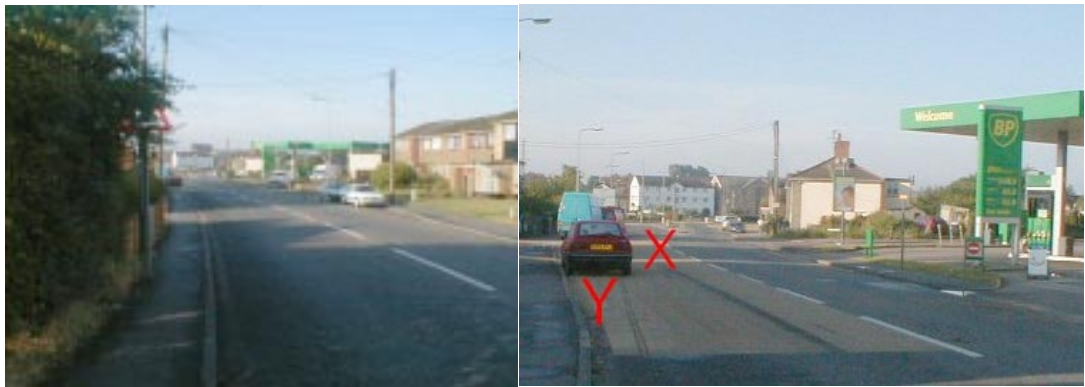
In the next two pictures we see the junction of Chalks Road with Braintree Rd. There are a lots of different movements, parked vehicles and a race-track effect from the slope of the railway bridge.

A cyclist has to claim their space in the middle of the road well in advance or risks being stranded not in a safe position by the kerb but against the vehicles parked on the left.

If a cyclist (red) can claim the right of the road in good time then they are able to hold up the following traffic (blue) by blocking their passage squarely. In the event of not being able to find a suitable gap the cyclist is forced to stop on the left and wait for a gap. Stopping at Y is sometimes possible but X (adjacent to a parked vehicle) is the normal refuge which as the green hatch shows is an invitation to be squeezed.

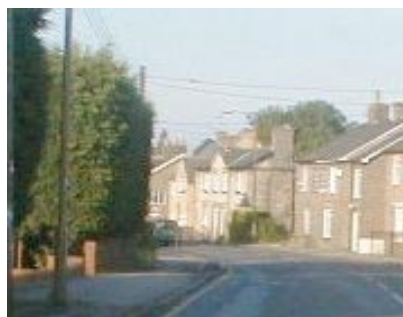
This photo is taken outside the Labour Hall. Just round the bend is the junction with Guithavon valley. A cyclist has to start claiming their road space from about this point to be sure of being seen as they go around the corner. Experienced cyclists find this junction quite tricky.

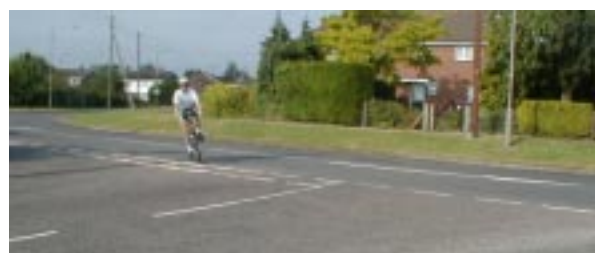
Another RH turn just after a bend. Junction of Spa Road and Guithavon Road.

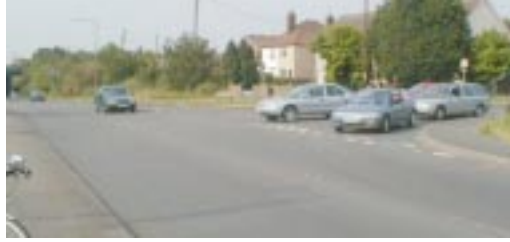
The junction between Maltings Lane and Maldon Road is in a 40mph area and is surprisingly busy. Trying to make a right turn here is daunting enough for an experienced cyclist, but a few feet of being in the wrong position can give drivers coming out of Maltings

Lane the wrong impression of your movements and they can be tempted to cut out into a gap in the traffic.

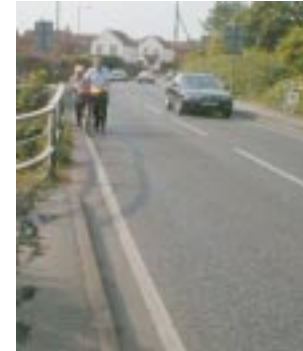
Here is the postman negotiating Sauls Bridge. This is long overdue for a footway on both sides. This is included here because it illustrates the legacy of infrastructure which has not been kept up to date with the needs of non-motorised road users even though traffic volumes have increased dramatically. With 6000 odd vehicle movements being generated by the Maltings lane development how many of those will use this road? How many people would walk? It is difficult to cross now at peak times -

what will it be like with even more traffic!

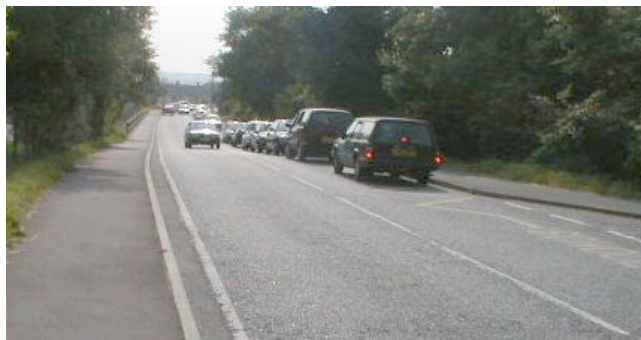
This is Maltings Lane just before school! There is a vicious circle of more cars...less safe roads... more parents drive... (In one study 43% said the reason for driving children to school was

fear of traffic.) This is a hazard for all road users, a major cause of congestion and concentrated air pollution.

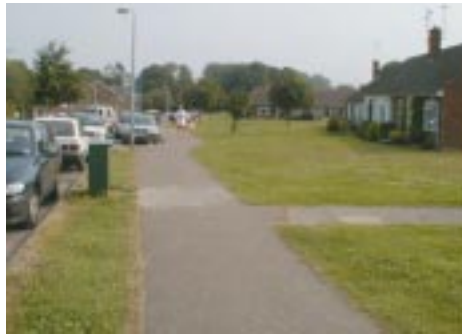
← Looking north

Is this wide verge in Howbridge road an opportunity for a dedicated cycle path?

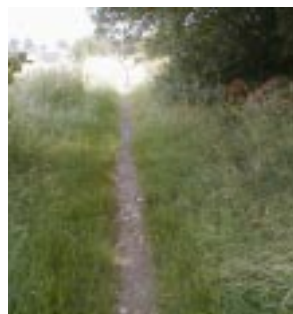
This is quite pleasant but the photograph doesn't show the encroaching overgrowth behind the camera.

This photo is looking north. A commuter from the south would have the town ahead to the left and the industrial estates on the right. Travelling time to the railway station could be less than the time taken to find a parking place then walk to the

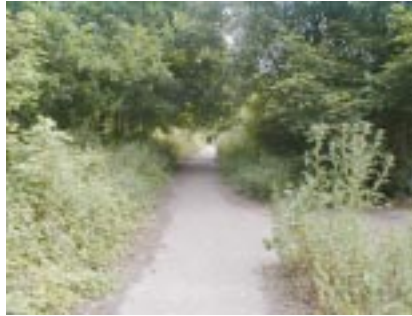
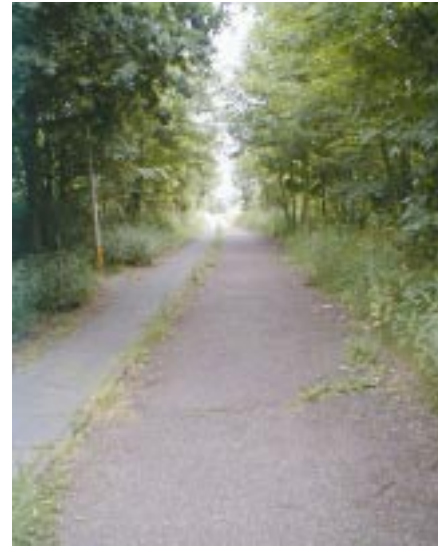
Continuing over Pasture Road, these photos show the hard surfaces in quite good condition and lush but not too serious vegetation. Very little work required here to make this an express commuter route.

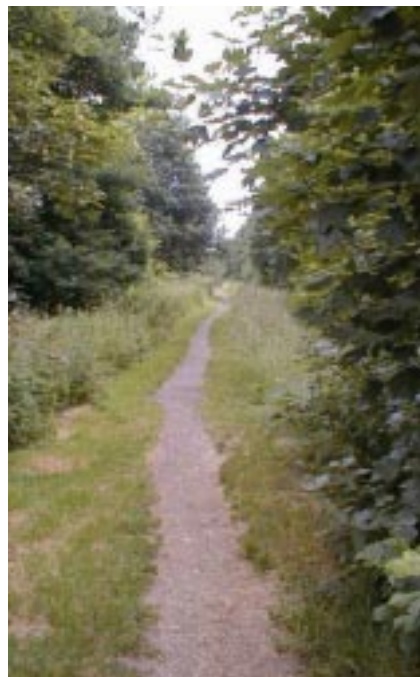
← After the junction with Chess Lane the trail reverts to natural surface. This is boggy, can be covered in glass and is not lit. These drawbacks need addressing.

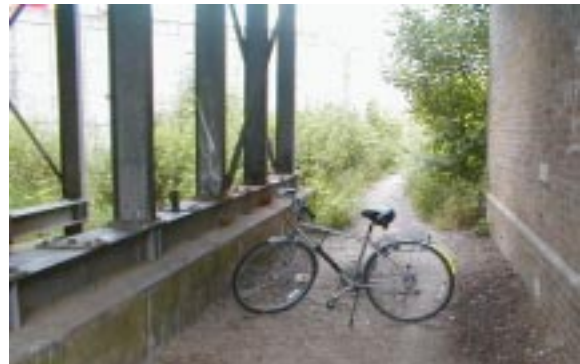
↓ Soon we arrive at the Catholic Bridge which leads through to Eastways and thence Motts Lane

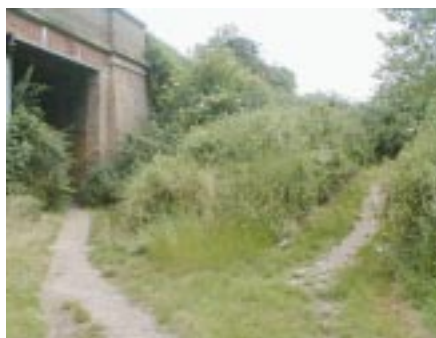
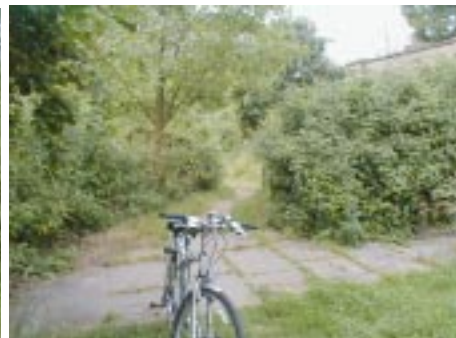
The left hand photograph below shows the South side of the bridge. The path seen on the right rises about a metre and is then practically level to Colchester Road. The right hand photo is pointing towards this spot with the trackbed visible above the handlebars. The paving in the foreground runs from the bottom of steps up to Colchester Road and an overgrown

footpath to Stepfield.
